Manhole Inspection Summary

Manhole # S47GG_035MH

Insp Date: **6/18/08 9:12 AM**

Location Address: **Llewelyn**

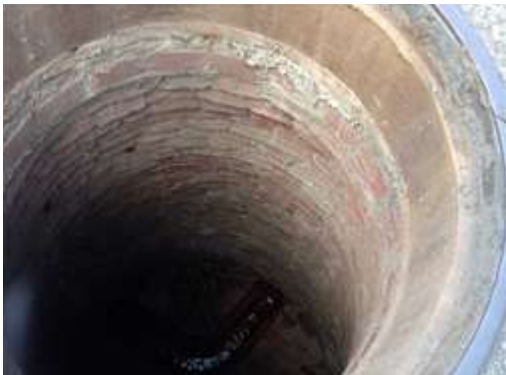
Defect 1

Infiltration: ☐ None ☐ Joint ☐ Cracks ☐ Mortar ☐ Roots ☒ **Wall**

infiltration

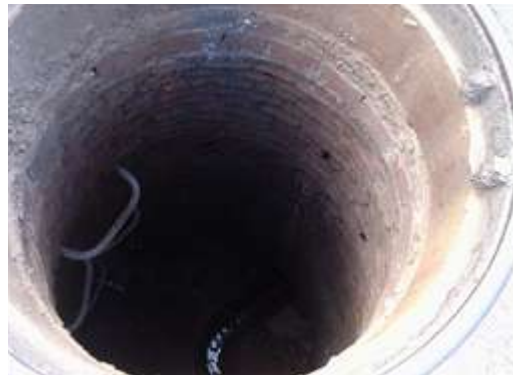
Defect 2

loose bricks

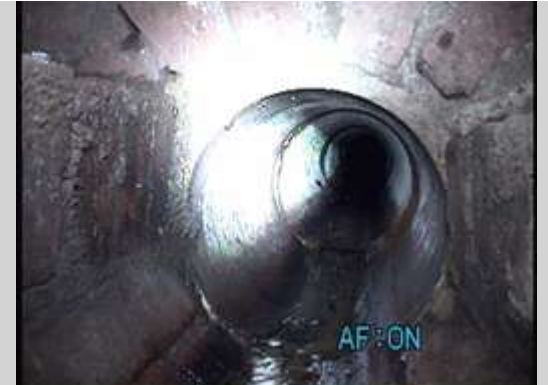
12 O'Clock Outflow

8 in. Circular Gravity Sewer
Pipe Out @ 12 O'Clock

Pipe Height: **8.4** (in.) Rod and Bar (Angled)
Pipe Material: **Clay** ☐ Pipe Lined
Invert Depth: **9.50** (ft.) Flow Characteristics: **Slow**
Deposits: ☒ None ☐ Mud ☐ Sludge ☐ Debris ☐ Grease
Silt Depth: (in.) Deposits Extent:
Infiltration: **None** Pipe Seal Cond: **Sound**

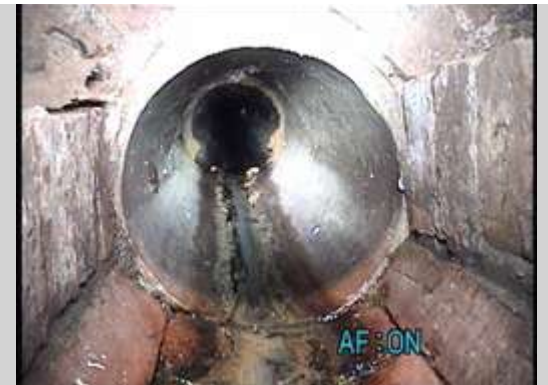
3 O'Clock Inflow

8 in. Circular Gravity Sewer
Pipe In @ 3 O'Clock

Pipe Height: **8.4** (in.) Rod and Bar (Angled)
Pipe Material: **Clay** ☐ Pipe Lined
Invert Depth: **9.45** (ft.) Flow Characteristics: **Slow**
Deposits: ☒ None ☐ Mud ☐ Sludge ☐ Debris ☐ Grease
Silt Depth: (in.) Deposits Extent:
Infiltration: **None** Pipe Seal Cond: **Sound**
